Resolving Air Gap Leak

Repair Time: 5 Minutes

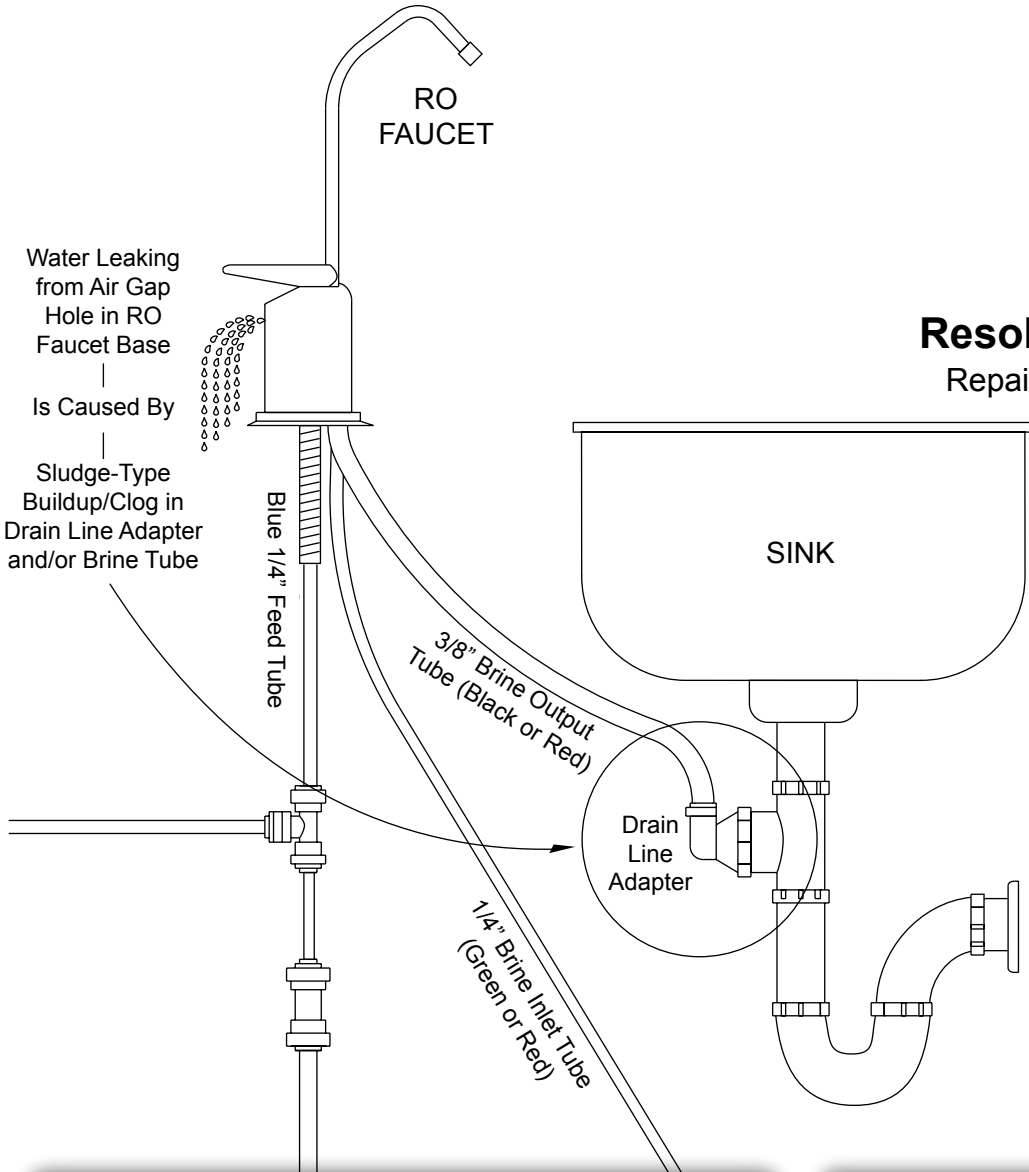
An Air Gap leak occurs when a blockage in the Brine Output Tube prevents rinse water from escaping to the sink drain.

RO systems rinse away removed contaminants to the sink drain via a 3/8" tube. When a blockage occurs in the drain system, rinse water will back up and spill out of the Air Gap hole located below the fill lever of the RO faucet. Typical blockages result from either buildup of biofilm, or other debris (ie food) in the drain.

Repair Air Gap leak by removing debris lodged in the Drain Adapter and 3/8" Brine Output Tube.
