# TEST REPORT

**Sample Name** : Outdoor Speaker

**Sample Model** : SLS LS6 STA

## Test Item 1: IP6X

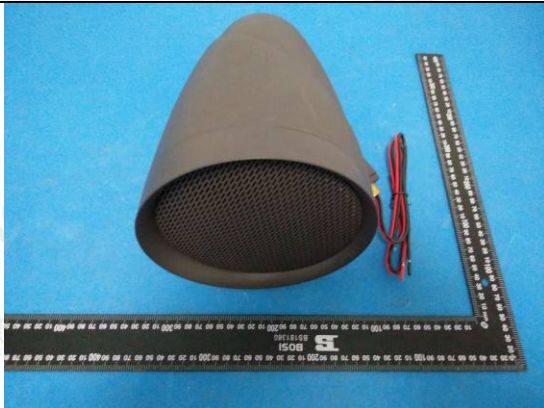
001

**Sample Photo before the Test:**

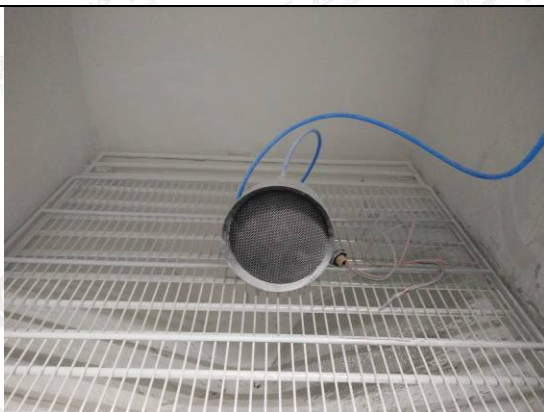
001

- 1) Set the samples in the dust chamber, the pressure inside the enclosure is maintained below the surrounding atmospheric pressure by a vacuum pump (Pump speed: 15mL/min, less than 40 times of the shell volume per hour; the differential pressure between the containment and the atmosphere  $\leq 2$  kPa),
- 2) Test time: 8 hours,
- 3) Dust content of Dust Tester: 2 kg/m<sup>3</sup>.

**Sample Photo during the Test:**

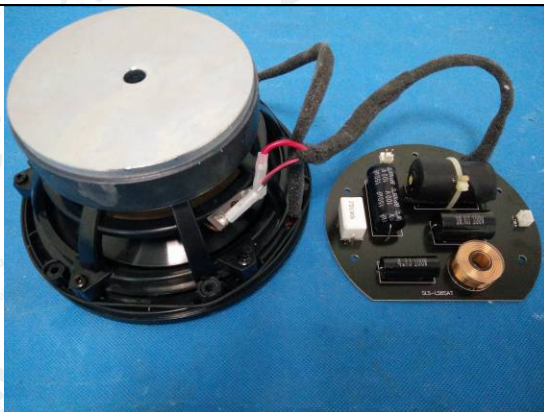
| Sample No. | Test Results Description | Conclusion |
|---|---|---|
| 001 | After the test when judged by visual observation, no dust entered into the sample. | Pass |

**Sample Photo after the Test:**

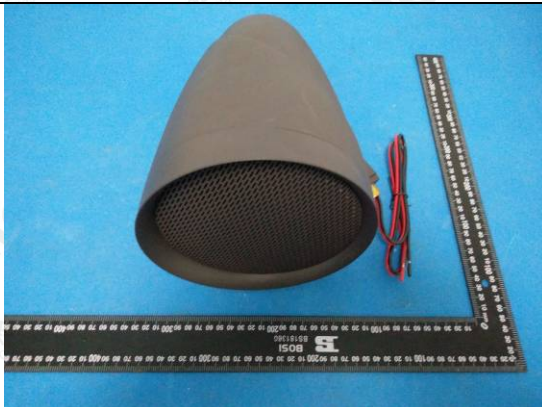
002

**Sample Photo before the Test:**

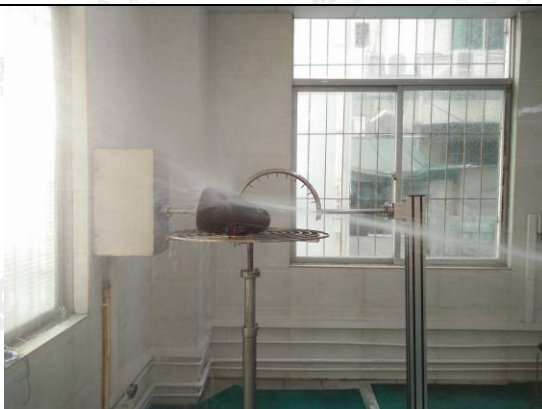
002

1. The rotation speed of the turntable: 1rpm;
2. Diameter of the nozzle: 12.5mm;
3. Water flow rate: 100L/min;
4. Distance from sample surface to nozzle: 2.5m~3m;
5. Test duration: 3min.

**Sample Photo during the Test:**

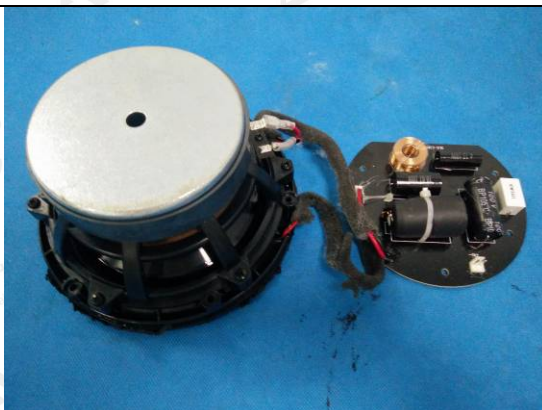
| Sample No. | Test Results Description | Conclusion |
|---|---|---|
| 002 | After the test when judged by visual observation, no water entered into the sample. | Pass |

**Sample Photo after the Test:**
