TEST REPORT

Report No: GTS20240514017-3-1

Sample Name Mariner MX speakers

Testing items: IP6X

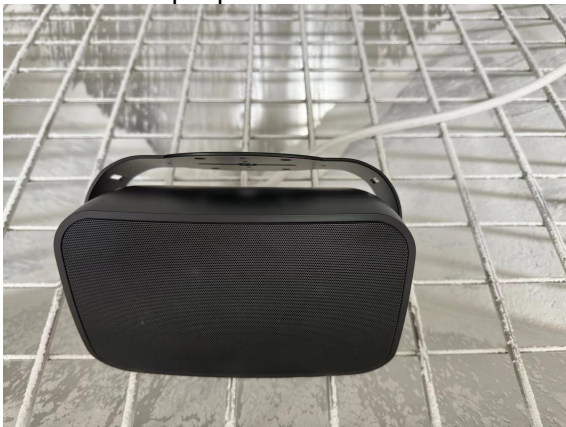
Sample 93604 MARINER MX52 BLK

Sample placement status

5) Test result: after the test, the sample has no dust entering phenomenon, and the test is qualified.

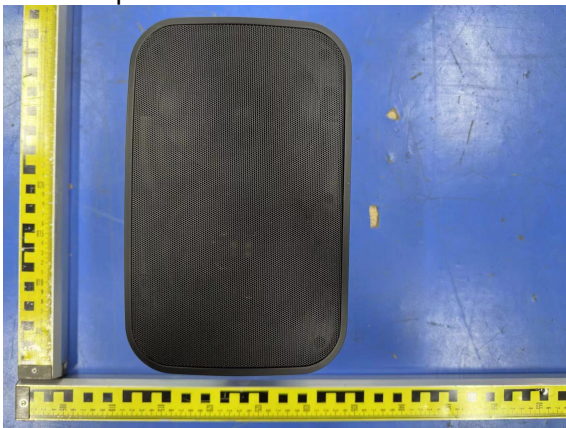
Sample 93604 MARINER MX52 BLK

Sample placement status

5) Test result: after the test, the sample has no water intake phenomenon, and the test is qualified.
