TEST REPORT

Report No: GTS20240514017-3-1

Sample Name Mariner MX speakers

Testing items: IP6X

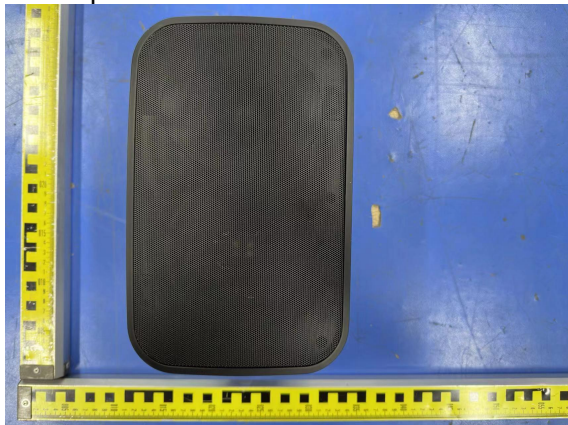
Sample 93604 MARINER MX52 BLK

Sample placement status

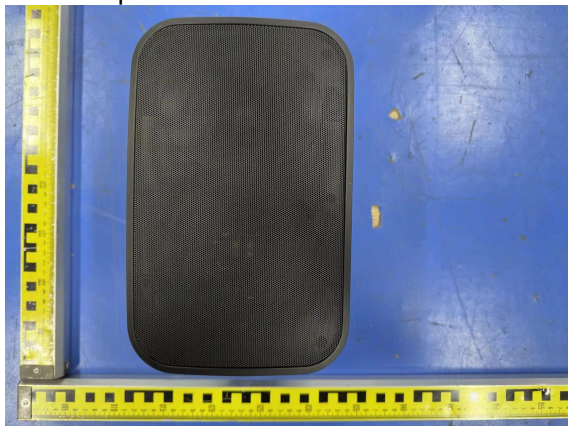
Sample 93604 MARINER MX52 BLK

Sample placement status
