# TEST REPORT

**Sample Name** : Outdoor Speaker

**Sample Type** : SLS LS4 STA

## Test Item 1: IP6X

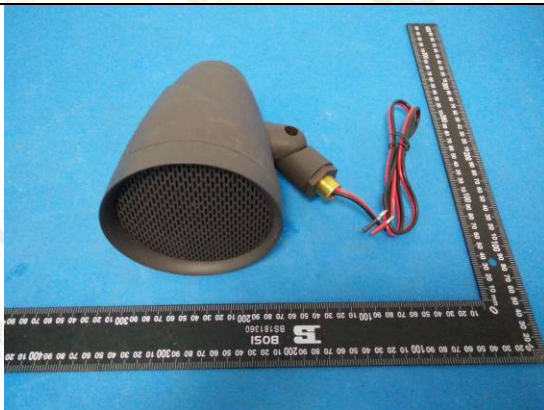
001

**Sample Photo before the Test:**

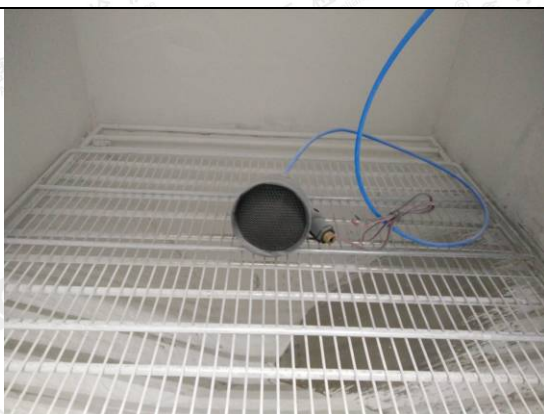
001

- 1) Set the samples in the dust chamber, the pressure inside the enclosure is maintained below the surrounding atmospheric pressure by a vacuum pump (Pump speed: 15mL/min, less than 40 times of the shell volume per hour; the differential pressure between the containment and the atmosphere  $\leq 2$  kPa),
- 2) Test time: 8 hours,
- 3) Dust content of Dust Tester: 2 kg/m<sup>3</sup>.

**Sample Photo during the Test:**

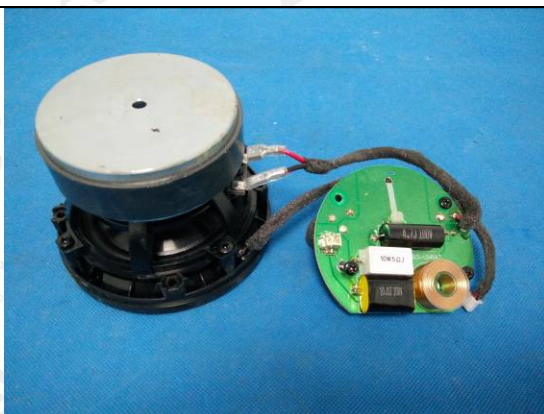
| Sample No. | Test Result Description | Conclusion |
|---|---|---|
| 001 | After the test when judged by visual observation, no dust entered into the sample. | Pass |

**Sample Photo after the Test:**

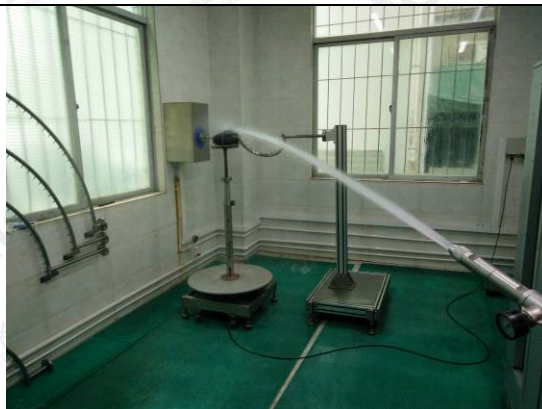
002

1. The rotation speed of the turntable: 1rpm;
2. Diameter of the nozzle: 12.5mm;
3. Water flow rate: 100L/min;
4. Distance from sample surface to nozzle: 2.5m~3m;
5. Test duration: 3min.

**Sample Photo during the Test:**
