# ROUND GRATE/COVER REPLACEMENTS

Rev. -  
 Date: 10/13/2021  
 C.N. No. 144086  
 Prod. | Dwg. No. FD137

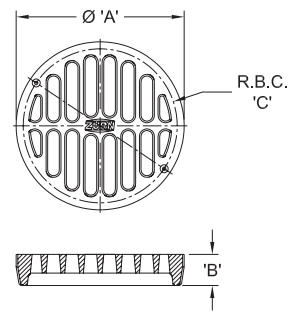
Z547						
Item No.	Diameter 'A'	Rim Thickness 'B'	R.B.C. 'C'	Open Area. Sq. In.	Ordering No.	Casting No.
55	19-7/8"	1"	9-5/8"	112	P547-GRATE	82901-1

Z554						
Item No.	Diameter 'A'	Rim Thickness 'B'	R.B.C. 'C'	Open Area. Sq. In.	Ordering No.	Casting No.
56	6"	5/16"	2-23/32"	8	P554-GRATE-USA	56628-1

Z556						
Item No.	Diameter 'A'	Rim Thickness 'B'	R.B.C. 'C'	Open Area. Sq. In.	Ordering No.	Casting No.
57	6-3/4"	1-1/4"	3-3/32"	13	P556-GRATE	51351-1

Z730						
Item No.	Diameter 'A'	Rim Thickness 'B'	R.B.C. 'C'	Open Area. Sq. In.	Ordering No.	Casting No.
58	8-1/4"	9/16"	-	24	P525-T-GRATE-USA	7549-1

Z742-2SP						
Item No.	Diameter 'A'	Rim Thickness 'B'	R.B.C. 'C'	Open Area. Sq. In.	Ordering No.	Casting No.
59	7"	1/4"	3"	13	P742-GRATE-2	38261-1
